# Coconino National Forest

## FN708 Conceptual Remedial Strategies

Stephen Romero, P.E.  
USDA Forest Service

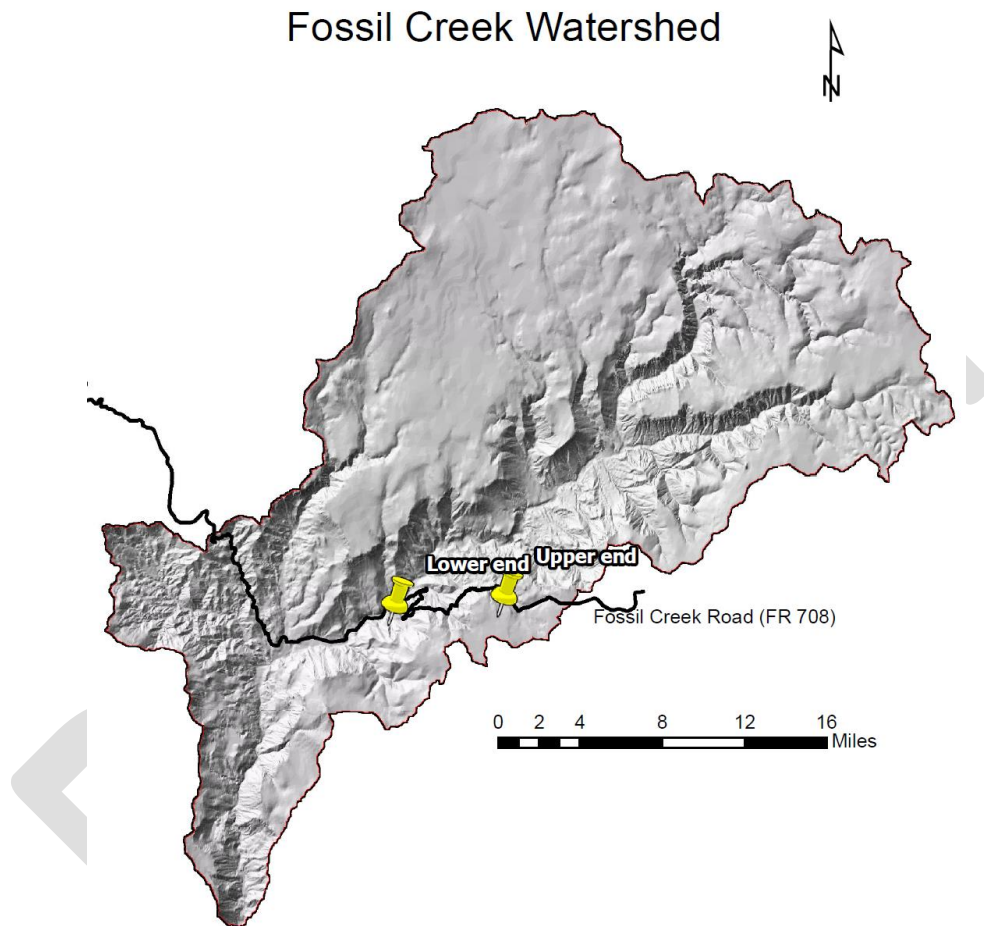
**Figure 1:** Fossil Creek watershed. Markers indicate approximate limits along Fossil Creek road viewed as most hazardous to pedestrians and motor vehicles.

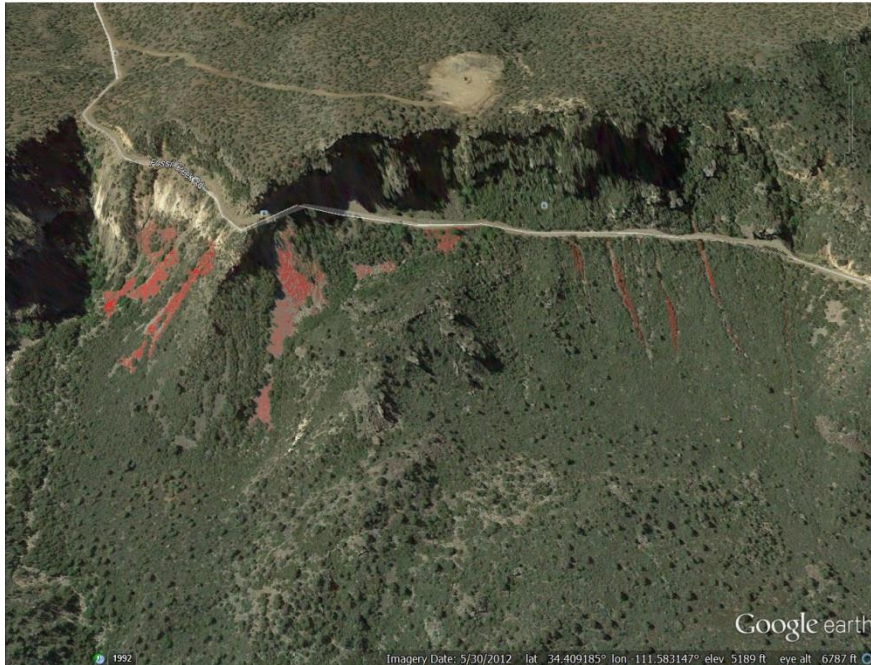
Fossil Creek road is susceptible to rock avalanche, debris flows, and rockfall events. Evidence of relatively recent events is apparent all along the section of Fossil Creek road contained within the Fossil Creek watershed. This is especially true in the upper reaches of the road where it enters the watershed.

**Figure 2:** Red highlights indicate areas of recent rockfall, rock avalanche, and debris flow activity.

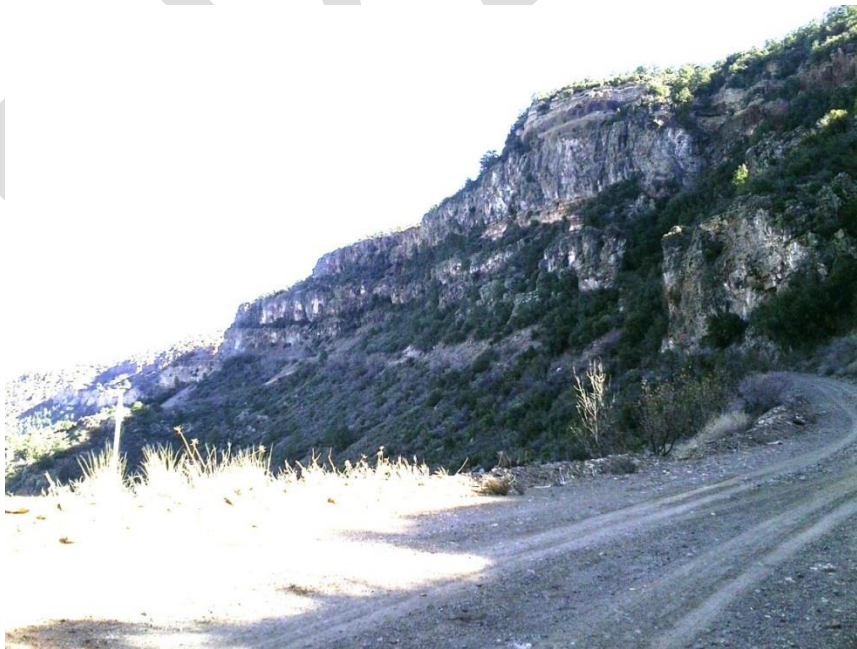
**Figure 3:** Example of rockfall/avalanche sources along Fossil Creek road.

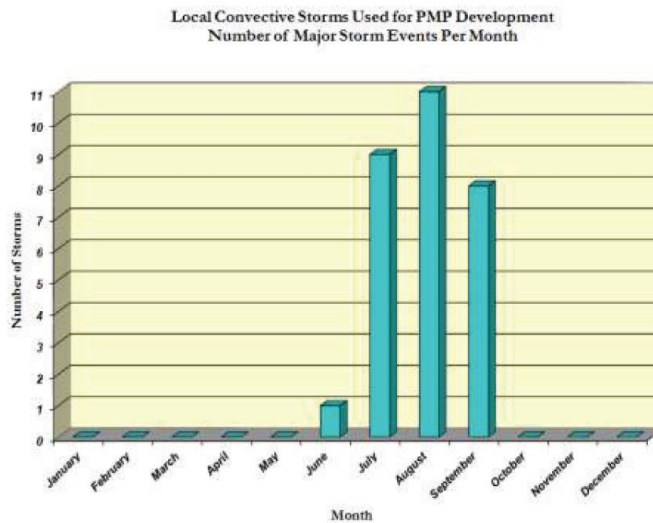
Analysis of existing rainfall data, NOAA Atlas 14, and PMP studies conducted in Arizona show the distribution of significant rainfall events in the Fossil Creek watershed occur primarily in the months of July, August, and September – the peak recreation period.

**Figure 4:** Distribution of local convective storms used in regional PMP study which includes the Fossil Creek Watershed.

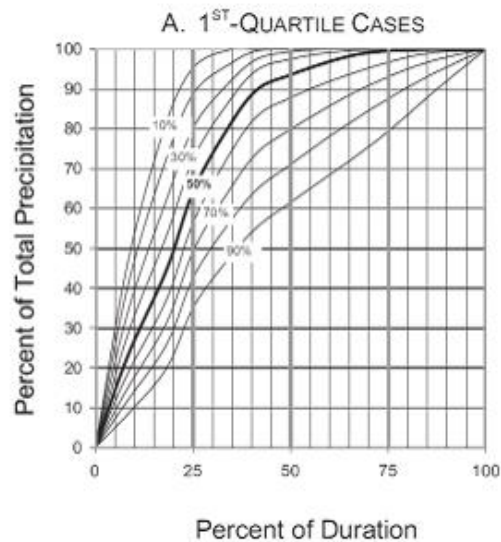
Intense rainfall patterns have a positive correlation to flash floods, rockfall, rock avalanche, and debris flow events (M. Krautblatter, M. Moser 2009). In addition, a significant percentage of local storms that impact the Fossil Creek watershed appear to have a positive skew – a large proportion of the total rainfall generated by a storm event occurs at the beginning of the storm. Given the relatively short lead time – indication that rain is approaching – risk from such storms could be significantly elevated over other local storms with much more uniform rainfall distributions.

**Figure 5:** Distribution of total rainfall in 25% of storms impacting Fossil Creek watershed. Note positive skew.

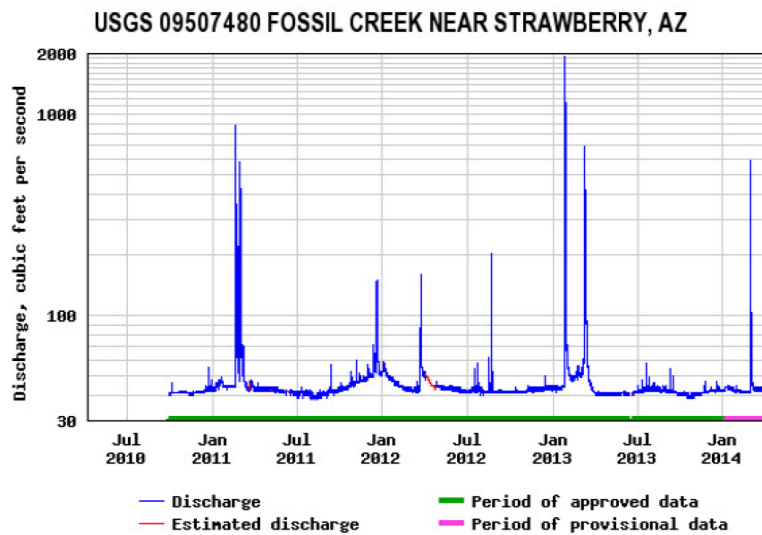
**Figure 6:** Fossil Creek Stream Gauge. Note spike in stream flow in August of 2012 possibly indicating extreme storm event.

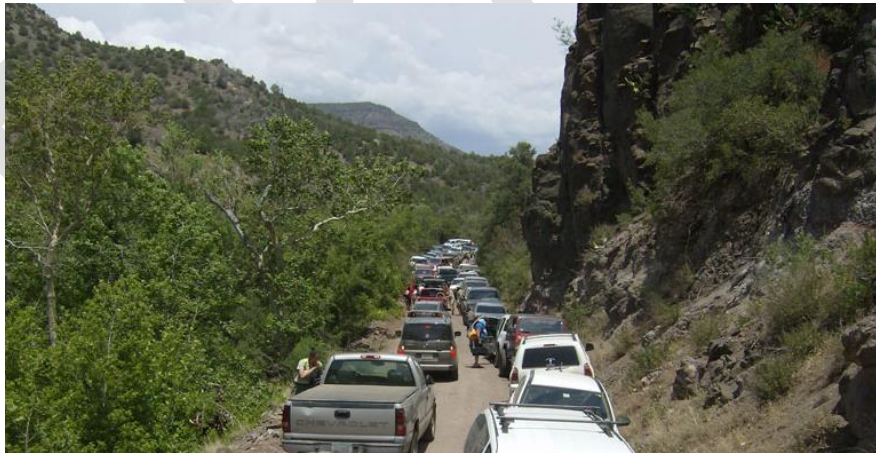
Due to the intersection of substantially increased peak usage and potential for extreme climatic conditions risk that pedestrians and motorists will encounter dangerous road conditions appears significant and will continue to increase as usage increases. A comprehensive geohazards evaluation will be required to quantify this risk – taking site conditions and usage trends into account.

**Figure 7:** Typical congestion along Fossil Creek road. Note unmitigated rockfall hazard adjacent to parked cars and pedestrians.

The geohazards assessment should include qualitative and, possibly, quantitative (to include probabilistic analysis) evaluation of the geohazards in the Fossil Creek watershed using generally

accepted methods. Such an assessment would more accurately quantify periods of increased risk and identify particularly hazardous areas/zones where risk is greatest.

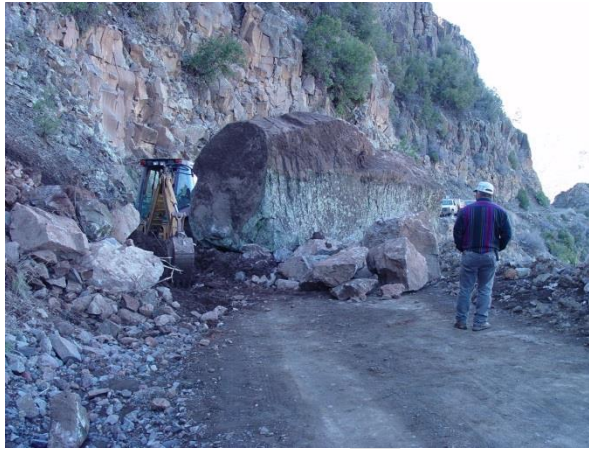
**Figure 8:** Example of rockfall event along Fossil Creek road

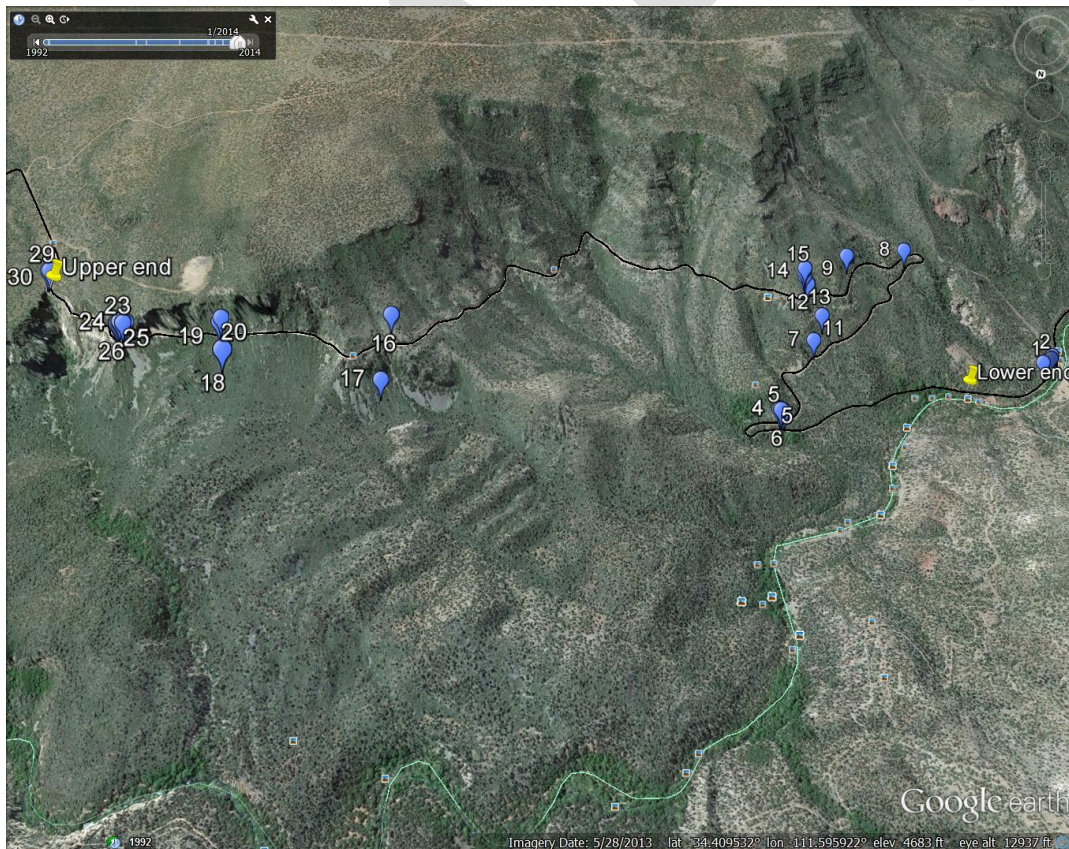
**Figure 9:** Location of proposed mitigations along Fossil Creek road.

The lack of road width all along Fossil Creek road provide little opportunity for the construction of a significant catchment. Locations of interest, depicted by points 1 through 30 in Figure 9, are included in kmz which is included with this report.

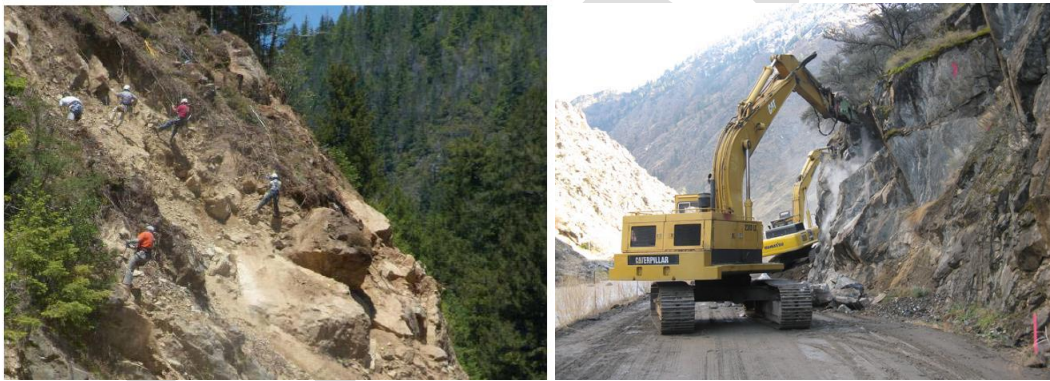
Scaling involves the removal of loose and unstable material from the slope face either by hand or with the aide of machinery – excavator, lift, etc.. Low yield explosives are sometimes utilized in scaling efforts – especially in instances where safety of the Contractor might be an issue. Scaling must be repeated periodically as site conditions warrant.

**Figure 10:** Hand scalers and heavy equipment removing loose material from slope (*from FHWA-CFL/TD-11-002*)

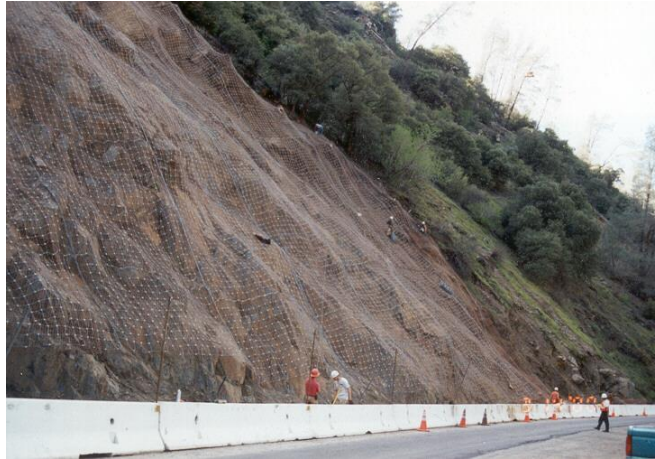
Rockfall netting is designed to confine/slow/stop rockfall. It is typically attached using anchor trenches or through a rockbolt/cable system. The rockfall netting is draped across the rockfall source face.

**Figure 11:** California DOT cable netting project. Note jersey barriers installed as catchment impact barrier to trap material conveyed by the netting.

When rock breaks away from the rock face it interacts with the rockfall netting slowing its fall and damping the amplitude of the rock bounces. Rockfall is conveyed to the bottom of the rockfall drape where it can be easily removed. Twisted wire configurations are typically utilized for rock diameters less than 1 foot. Cable reinforcing and cable nets are deployed for larger diameter boulders. Design limitations of the various systems are detailed by the manufacturer.

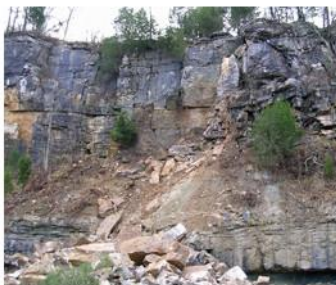
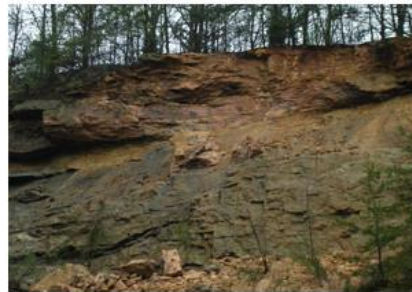
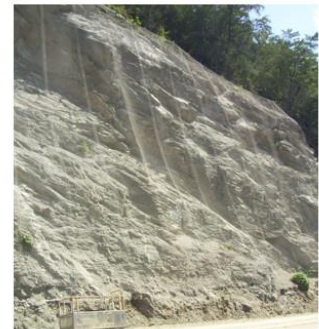
**Figure 12:** Tennessee DOT rockfall abatement project – scaling and rockfall netting.

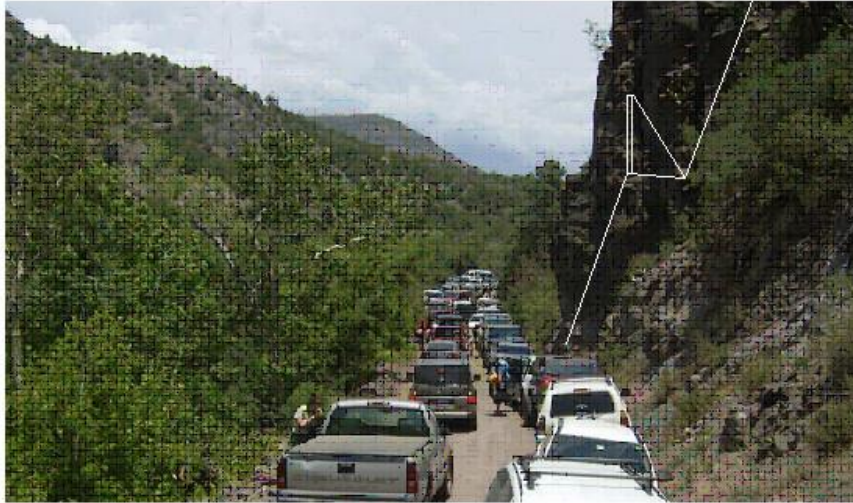
Resloping generally involves the reshaping/excavation of an existing slope to a more stable configuration. Resloping is usually accomplished by excavating with heavy equipment or through blasting - or in combination.

**Figure 13:** White line is one possible reconfiguration of existing slope – laying back slope and benching to install debris fence.

Points along Fossil Creek Road where applicable: Milepost 0 to .3 and 4.7 approximately.  
pics 1 - 3 and 22 - 25.

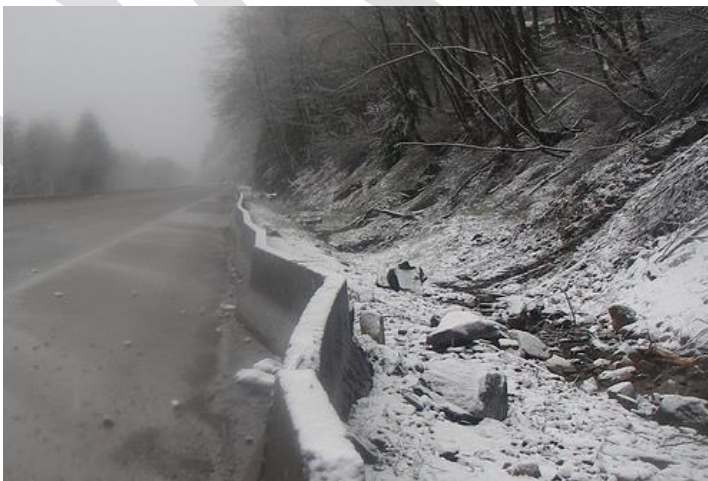
Impact barriers are utilized to contain rockfall conveyed by rockfall netting or along sections of road subject to low velocity rockfall – rockfall generated by relatively short slopes – that has a low probability of bouncing over the barriers.

**Figure 14:** Jersey barriers installed along catchment protecting road from rockfall.  
(Courtesy [slidingthought.wordpress.com](http://slidingthought.wordpress.com))

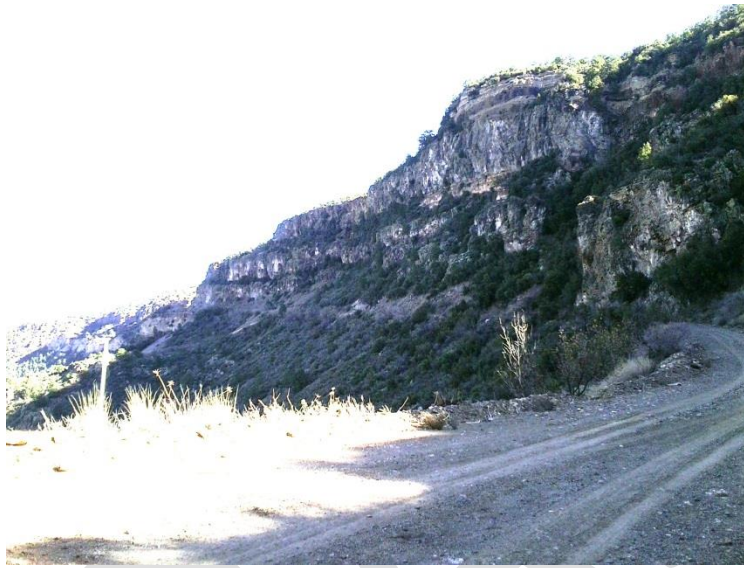
The upper reaches of Fossil Creek road, MP 0 to .81 approximately, is subject to relatively frequent impacts from large rockfall 3 foot in diameter or larger.

**Figure 15:** Large rockfall sources MP .25 to .81

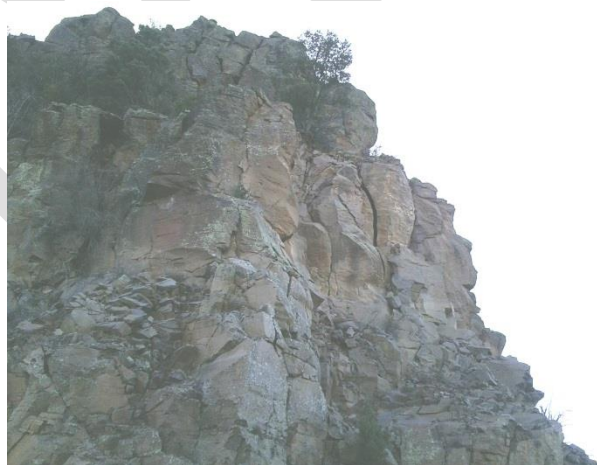
Given its proximity to the road, frequency of rockfall, apparent risk, and cost/benefit MP 0 to .3 is the section that offers the highest stabilized benefit.

**Figure 16:** Example of slope face adjacent to road MP 0 - .3

Scaling is first employed to remove loose, unstable, rock. Scaling of such a large volume of large rocks could be accomplished via mechanical means or through the careful placement of low yield explosives. Each area of instability would require significant planning and relatively intensive execution to insure safety and environmental concerns are addressed.

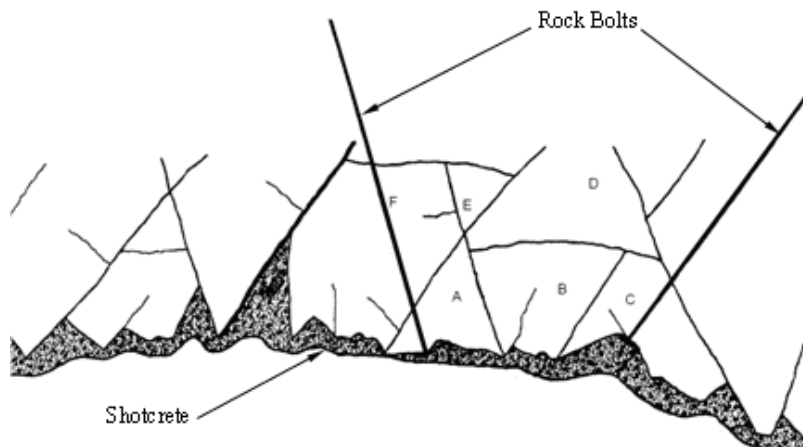
Generally accepted structural stabilization techniques include rock bolting primarily. A precursor to the development of any rock bolting plan is a detailed mapping of the rock face by a structural/engineering geologist. Such a mapping program will identify sources of instability in the slope face - joints, faults, and blocks – so that an effective/economical bolting plan can be developed.

**Figure 17:** Strategic placement of rockbolts to stabilize blocks that control overall stability of rockface. (Courtesy FHWA)

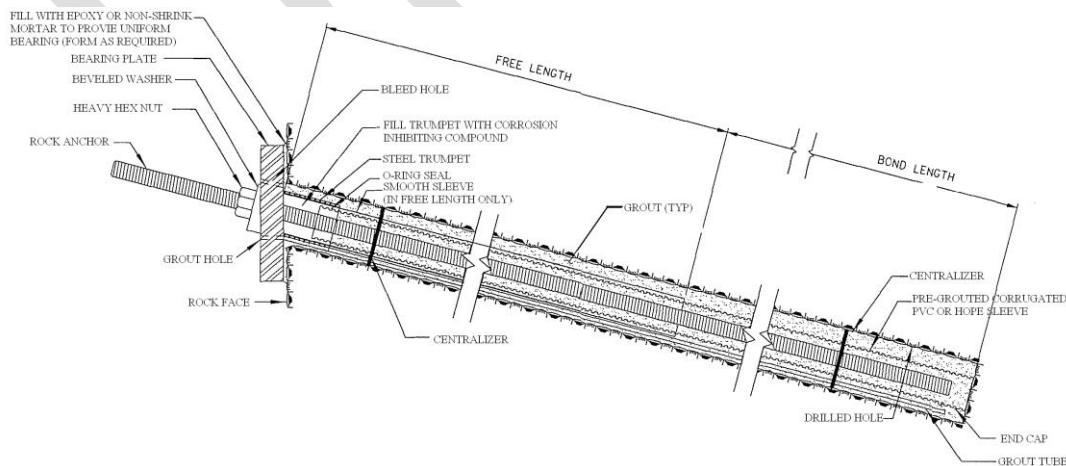
Once the rock bolts are installed to address local stability issues along the rock face rockfall netting or shotcrete is typically employed to abate long term rockfall risk from weathering.

**Figure 18:** Typical rockbolt section (Courtesy FHWA)

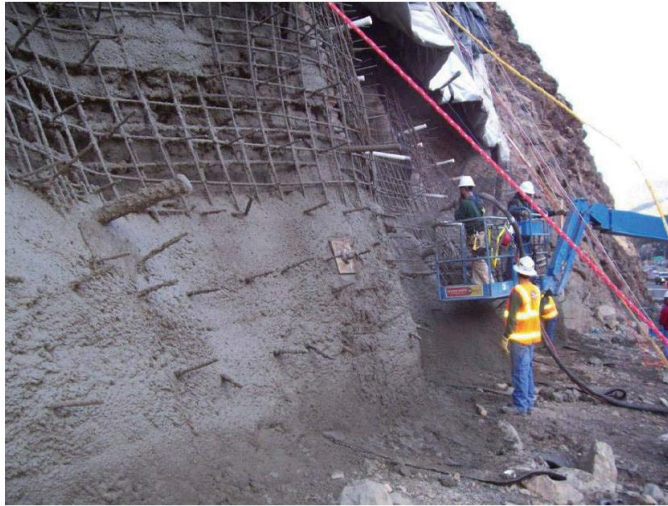
Reinforcement (rebar, welded wire) is sometimes installed over the rock face and shotcreted to provide structural support to the entire rock face at issue. Given the relatively narrow road prism along fossil creek road shotcreting may be required to insure risk is adequately addressed.

**Figure 19:** Installation of reinforced shotcrete face (*Courtesy FHWA*)

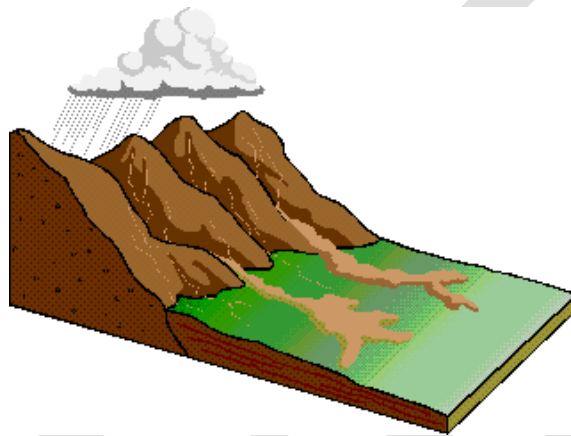
Debris flows are driven by rainfall. In the case of fossil creek road debris flows are likely generated by concentrated surface runoff being channeled by crevices in the rock face. Accumulated debris in those crevices is entrained by the high velocity flowing water which carries the material downslope. As the debris enters the road prism culverts are often plugged sending the remaining debris over the road surface. Since a significant amount of material is often entrained in the flow the scour potential is usually high which results in removal/entrainment of roadbed materials as the debris flow crosses the road. Ultimately, a trench is created making it impossible for traffic to cross.

**Figure 20:** Example of channelized debris flow generation and outcome (*Courtesy of USGS*).

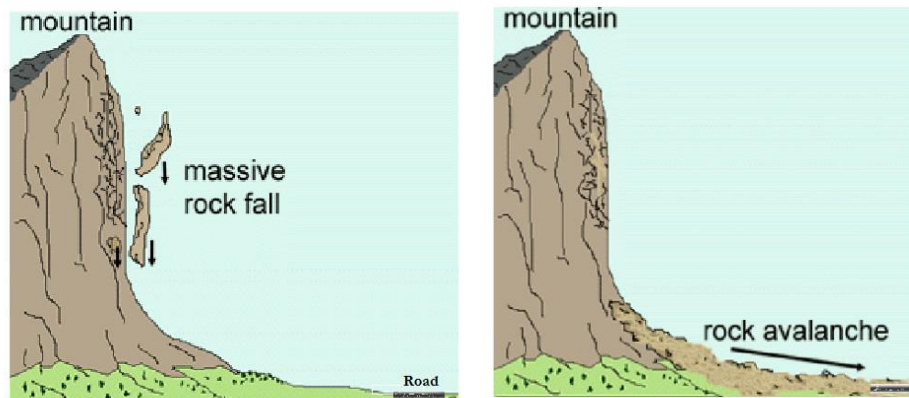
Rock avalanche are generated when a large rock formation breaks away from the rock face. Upon impact with the slope surface the rock shatters sending a cascading debris pile downslope.

**Figure 21:** Example of rock avalanche threat to road (*Courtesy of Prof. Brad Perry, CSU Long Beach*).

Remediation strategies for rock avalanches range from confined soil abutments, rock impact barriers, to rock nets/fences. Given the relatively narrow road prism rock nets and fences would likely be the most feasible option.

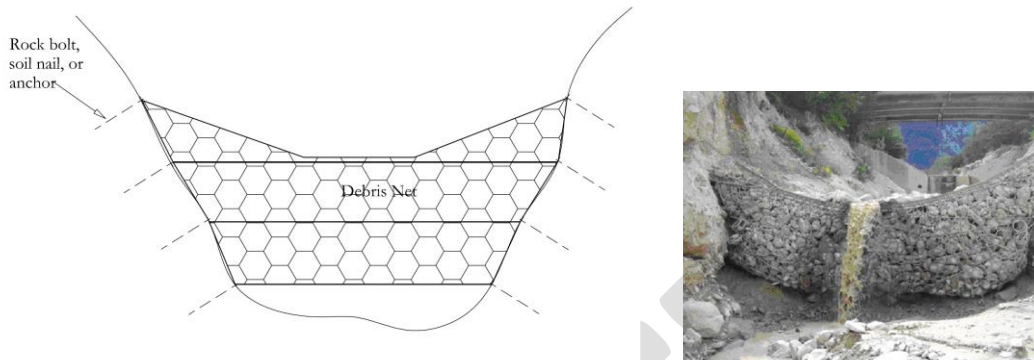
**Figure 22:** Rock net (*Courtesy of Swiss Federal Institute for Forest, Snow and Landscape Research WSL*)

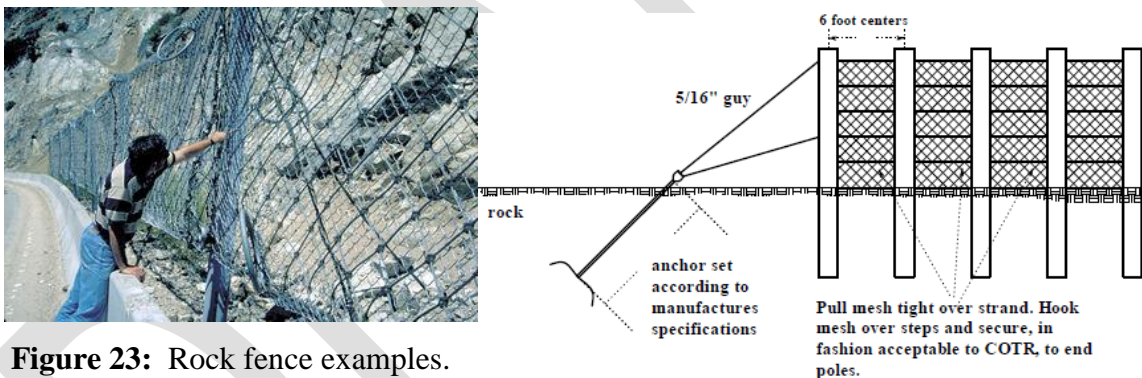
**Figure 23:** Rock fence examples.

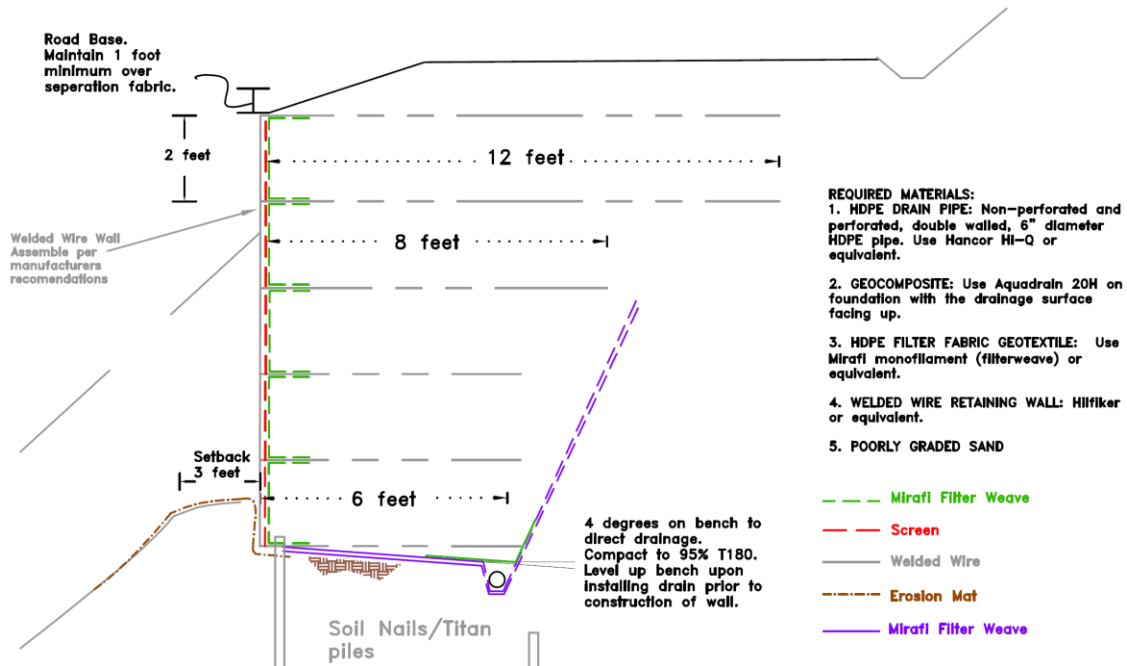
Due to the likelihood of intense rainfall over the life of any structure installed to repair road fill failures in the Fossil Creek watershed storm proofing remediation strategies should be employed. The most economical solution will be the installation of mechanically stabilized earth or rock walls (MSE or MSR). Welded wire walls are the most constructible and cost competitive. However, alternative configurations could be considered and are dependent on project budget limitations

**Figure 24:** Typical MSE configuration.

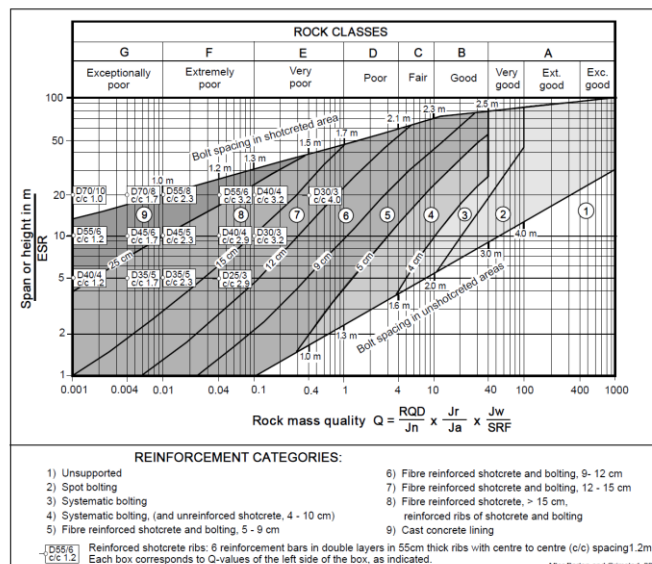
Alternatives that include a rock bolting program would likely be focused on spot bolting of segmented rock blocks, fissures, or other zones exhibiting potential for instability. The cost associated with spot bolting depends on access and difficulty. The area that spot bolting is most likely to be incorporated in any alternative is from MP 0 to .25. The unit cost of spot bolting is approximately \$200 per linear foot. Assuming a minimum 20 foot installed length and an average spot bolting radial spacing of approximately 15 feet total cost could exceed \$600,000.

**Figure 25: Rockbolting Q chart.**
